<b>Title of Change:</b>	Added comments and corrected typos in LV8907UWR2G datasheet and application note.	
<b>Effective date:</b>	1 July 2019	
<b>Contact information:</b>	Contact your local ON Semiconductor Sales Office or <Kei.Nagai@onsemi.com>	
<b>Type of notification:</b>	This Product Bulletin is for notification purposes only. ON Semiconductor will proceed with implementation of this change upon publication of this Product Bulletin.	
<b>Change Category:</b>	<input type="checkbox"/> Wafer Fab Change <input type="checkbox"/> Assembly Change <input checked="" type="checkbox"/> Test Change <input checked="" type="checkbox"/> Other <u>Added comments in datasheet and application note</u>	
<b>Change Sub-Category(s):</b>	<input type="checkbox"/> Manufacturing Site Addition <input type="checkbox"/> Material Change <input checked="" type="checkbox"/> Datasheet/Product Doc change <input type="checkbox"/> Manufacturing Site Transfer <input type="checkbox"/> Product specific change <input type="checkbox"/> Shipping/Packaging/Marking <input type="checkbox"/> Manufacturing Process Change <input type="checkbox"/> Other: _____

<b>Sites Affected:</b>	ON Semiconductor Sites: None	External Foundr

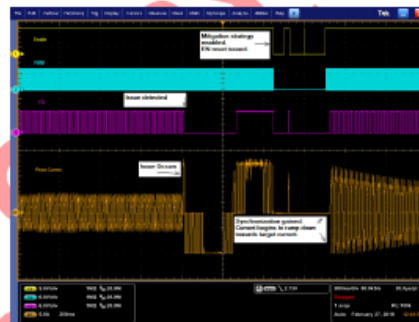
Figure 5. Example Waveform

LV8907UW doesn't always detect this loss of commutation synchronization and keeps trying to apply current to the motor windings based on a false BEMF zero cross detection. When the BEMF voltage polarity is inverted against the applied driving voltage, over current of the motor coil will occur. Therefore, there is the risk of physical damage caused by this unexpected over current.

Figure 5 shows example waveform in the case that the commutation synchronization is lost. The coil current (Orange plot) shows abnormally high currents. FG pulse period changes drastically.

Figure 5 also shows example waveform of resynchronization by toggling EN pin. The EN pin should be set low immediately when incoherent FG pulse detected in an actual application.

The FG pulse must be monitored. When the loss of commutation synchronization is detected by the abnormal FG pulse train described above, LV8907UW must be restarted. By setting the rotation enable pin, EN, to a logical low state, the driver output is deactivated to halt the over current situation. After this deactivation, the pin EN should be set logical high to restart. The LV8907UW will enter its normal startup sequence and regain synchronization. To enable this resynchronization of LV8907UW, the register bit named FRREN must be set 0. (See [datasheet](#) for detail).

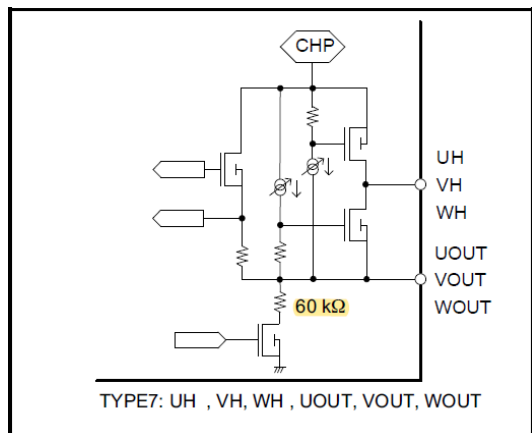
**11. The resistance marked yellow in the schematic below must be 60kΩ.**
